Lidstone and Associates, Inc.
Engineering, Geology and Water Resource Consultants

Re: Water Distribution System Operational and Infrastructure Improvements

WATER DISTRIBUTION SYSTEM OPERATIONAL AND INFRASTRUCTURE IMPROVEMENTS

January 9, 2015

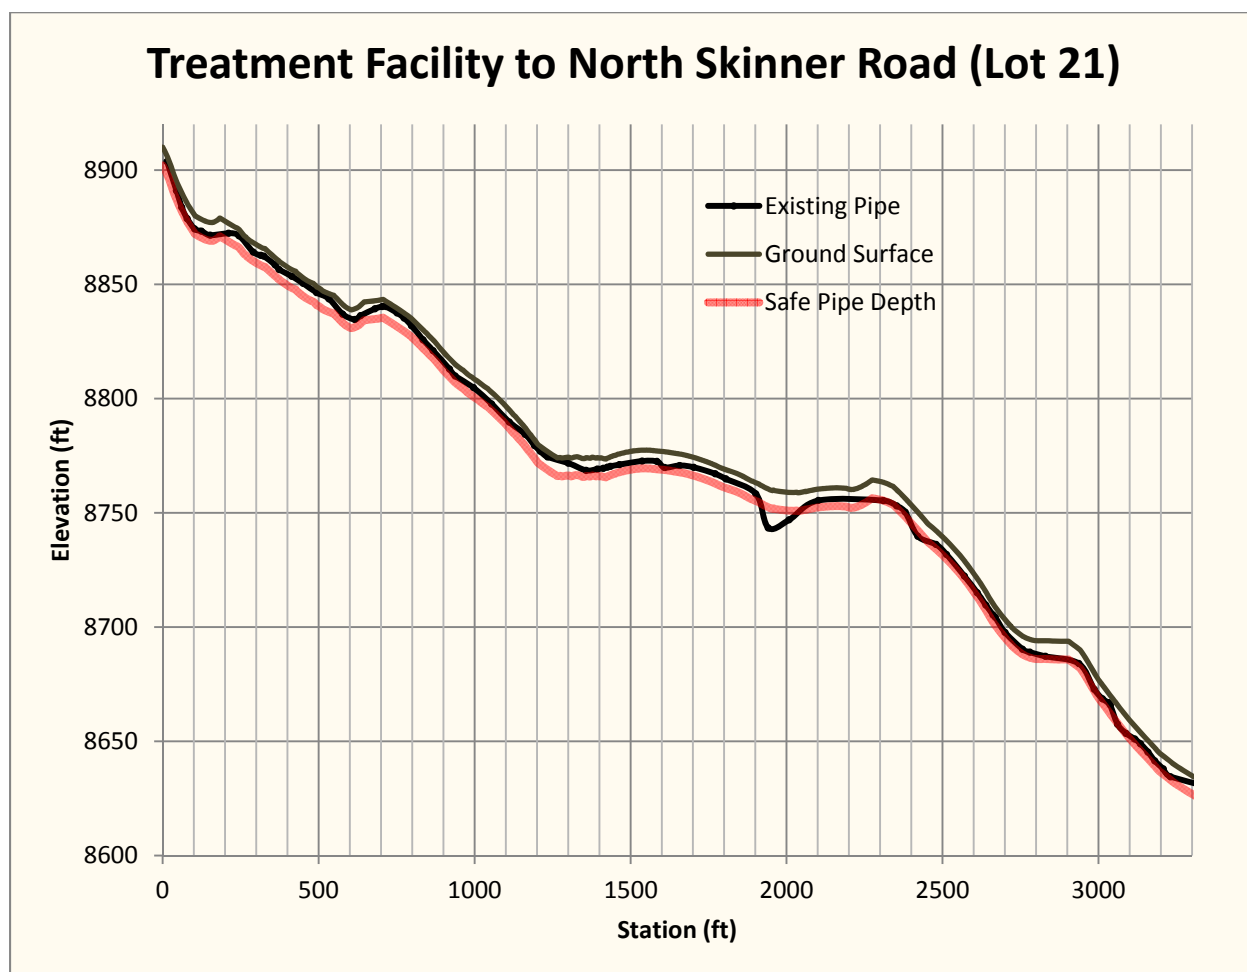
Figure 2 Depth Analysis for Priority 2

Priority 2) Replace the low pressure distribution system pipe from the treatment facility along South Skinner Road to the junction with North Skinner Road (3,700 feet of 4-inch PVC pipe). Based on the depth analysis survey (see **Figure 2**), this section of the low pressure distribution system appears to represent the highest risk of freezing due to the shallow depth of bury. **Figures 2-5** translate measured-in-place depth survey information to elevations based on USGS 5 ft contour topographic data.

The available data indicate the following percentage of the pipe length buried to the associated depths:

- 30% buried to a depth of less than 4 feet.
- 54% buried to a depth of less than 5 feet.
- 78% buried to a depth of less than 6 feet.

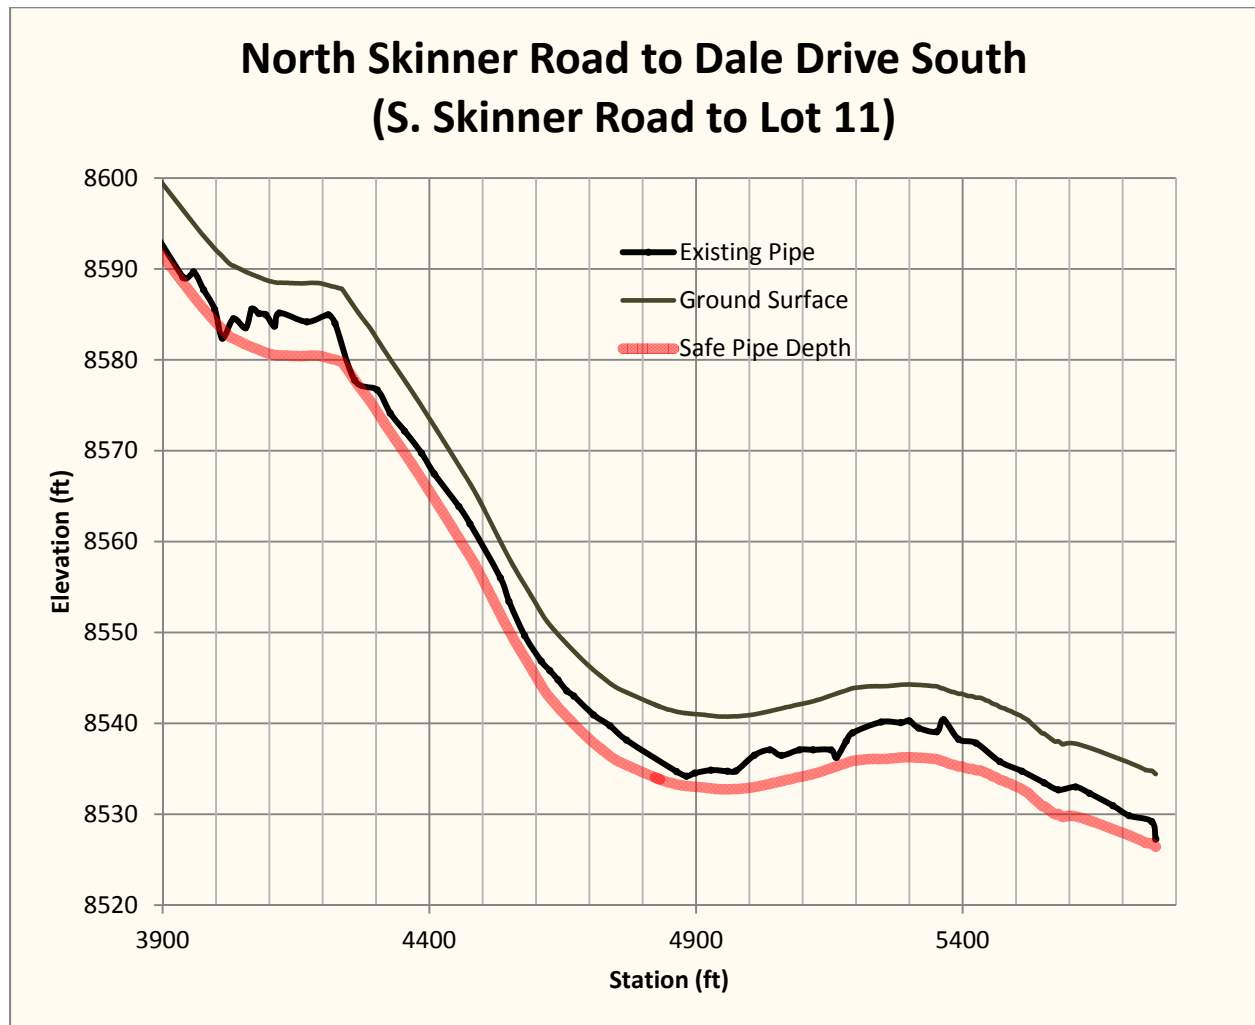
Figure 3 Depth Analysis for Priority 3

Based on the depth analysis survey (see **Figure 3**), this section of the low pressure distribution system appears to represent the second highest risk of freezing due to the shallow depth of bury. The available data indicate the following percentage of the pipe length buried to the associated depths:

- 15% buried to a depth of less than 4 feet.
- 48% buried to a depth of less than 5 feet.
- 88% buried to a depth of less than 6 feet.

Priority 3) Replace the low pressure distribution system pipe along North Skinner Road from South Skinner Road to Dale Drive South (approximately 500 feet). Continue replacement of low pressure distribution system pipe along Dale Drive South to Lot 11 (approximately 1,500 feet of 4-inch PVC pipe). It would be preferable to loop this pipe to the Dale Drive North pipe, depending on hydraulic analysis (length, placement, and possible pumping requirements to be determined).

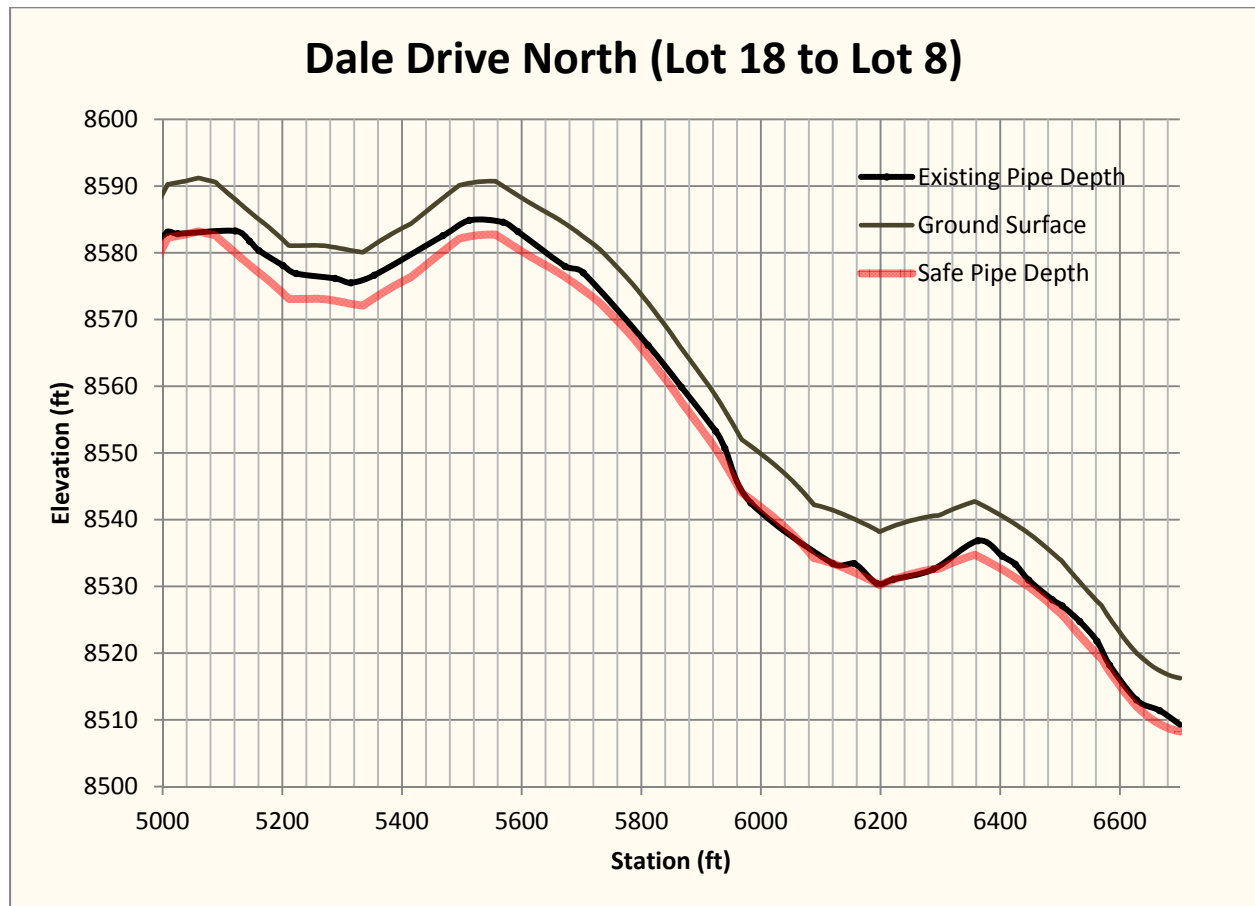
Figure 4 Depth Analysis for Priority 4

Priority 4) Replace the low pressure distribution system pipe along Dale Drive North from North Skinner Road to Lot 8 (1,700 feet of 4-inch PVC pipe). Complete pipe loops as necessary (length and possible pumping needs to be determined). The available depth analysis survey results (see **Figure 4**) indicate the following percentage of the pipe length buried to the associated depths:

- 22% buried to a depth of less than 5 feet.
- 59% buried to a depth of less than 6 feet.

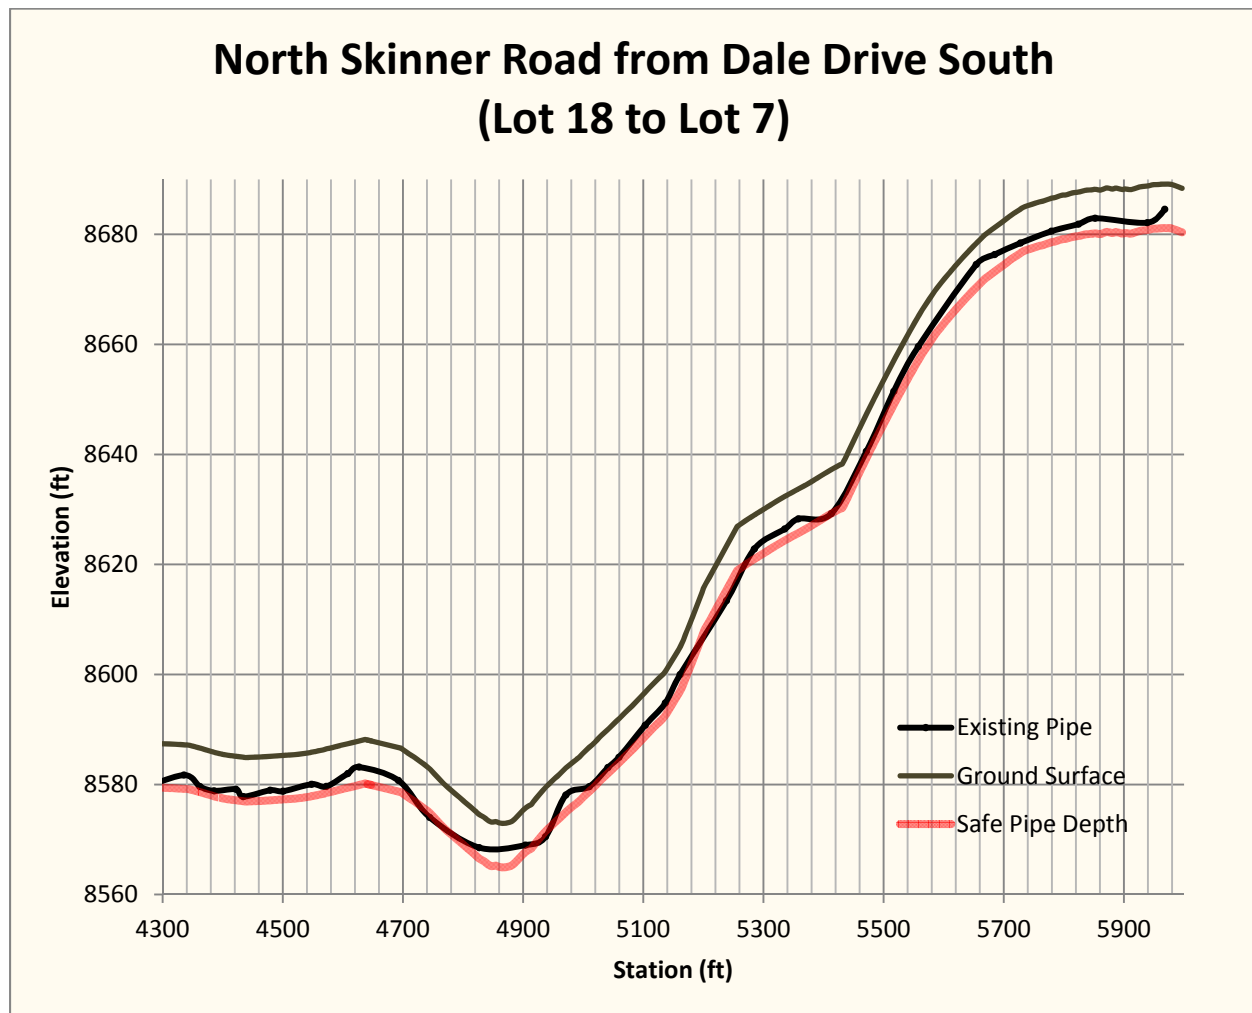
Figure 5 Depth Analysis for Priority 5

Priority 5) Replace the low pressure distribution system pipe along North Skinner Road from Dale Drive South to Lot 7 (2,700 feet of 4-inch PVC pipe). Loop connection from Lot 7 to Dale Drive North pipe (length and possible pumping needs to be determined). The available depth analysis survey results (see **Figure 5**) indicate the following percentage of the pipe length buried to the associated depths:

- 15% buried to a depth of less than 5 feet.
- 51% buried to a depth of less than 6 feet.

While “only” 51% of the length of this pipe section is shallower than 6 feet deep, it is important to note that more than 90% of this section’s pipe length is buried to a depth of less than 8 feet.
